Manhole Inspection Summary

Manhole # S29QQ_004MH

Insp Date: **6/19/07 9:30 PM**

Location Address: **2701 FALLS RD**

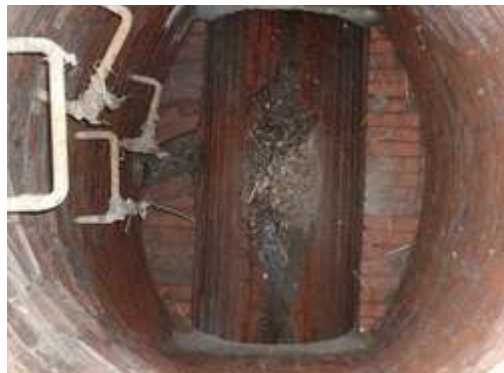
Top View

Corroded steps. Evidence of surcharge - Bench debris. Channel debris.

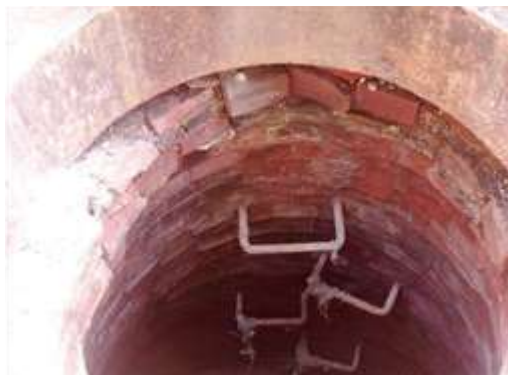
Defect

Frame leaks. Adjustment deterioration, loose brick and infiltration. Barrel infiltration - other side.

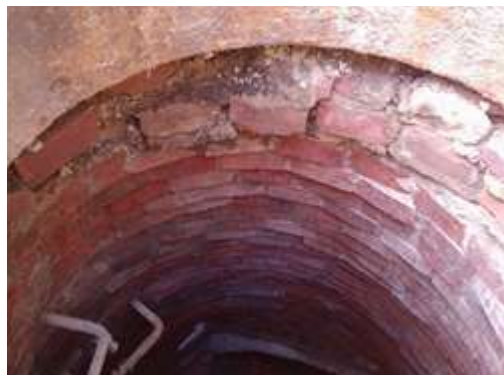
Defect

Frame leaks. Adjustment deterioration, loose brick and infiltration. Barrel infiltration.

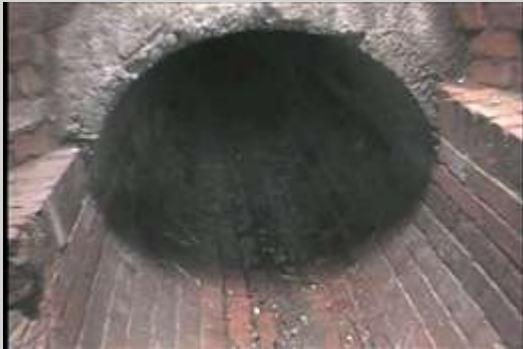
27 in. Circular Gravity Sewer Pipe Out @ 12 O'Clock

Deposits: ☒ None ☐ Mud ☐ Sludge ☐ Debris ☐ Grease

Infiltration: **None** Pipe Seal Cond: **Unknown**

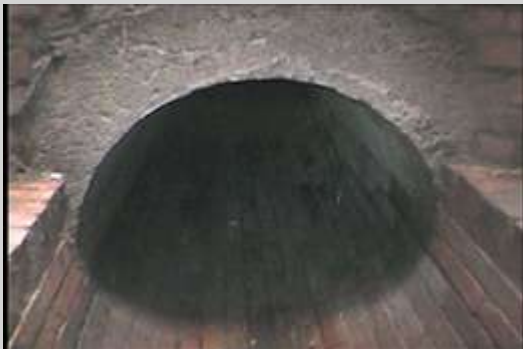
27 in. Circular Gravity Sewer Pipe In @ 6 O'Clock

Deposits: ☒ None ☐ Mud ☐ Sludge ☐ Debris ☐ Grease

Infiltration: **None** Pipe Seal Cond: **Unknown**

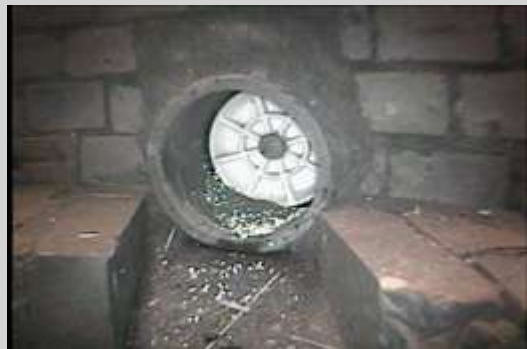
8 in. Circular Gravity Sewer

Capped.

Connects To: **Stub connection / abandoned**
